TECHNICAL SERVICE BULLETIN

REFERENCE: SPS801TS, SPS802TS, SPS801TSE, SPS802TSE

SUBJECT: SUB PCB ASSEMBLY

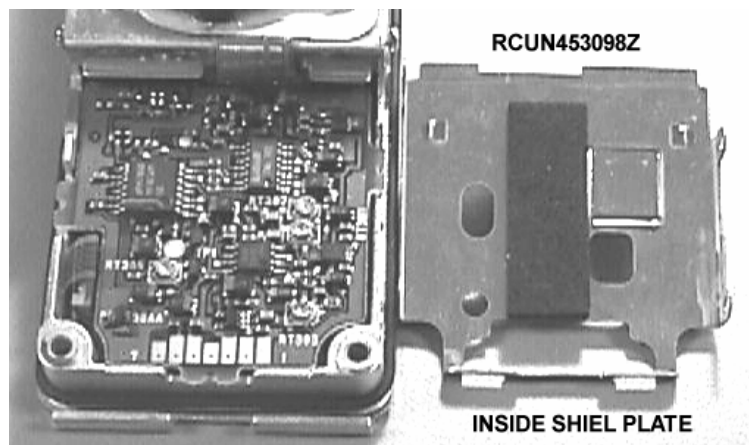
GENERAL: It has been brought to our attention that it is possible for the SUB PCB to pop loose from J111 causing decode failure. This may occur when radio is dropped several times, usually face down.

To prevent the possibility of this happening we suggest that a foam cushion part number RCUN453098Z, or something similar, be added inside the lower shield plate as shown below. Be careful not to cover the adjustment potentiometers.
