TECHNICAL SERVICE BULLETIN

REFERENCE: IMH4100DT

SUBJECT: Receiver Front End Overload

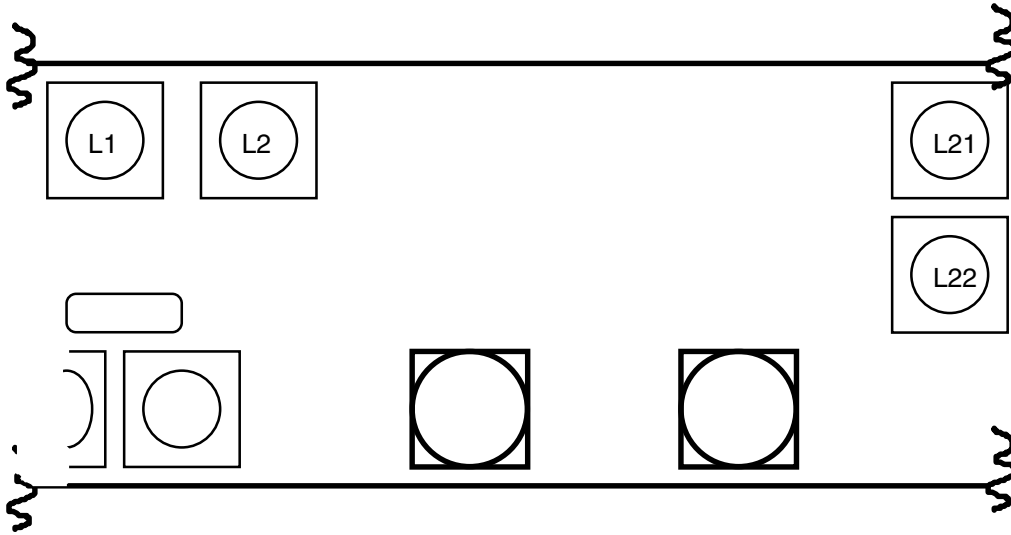
GENERAL: This *does not* pertain to all radios. Some radios have exhibited poor receive sensitivity after transmission at close proximity to high power stations. But, when radio is turned off and back on, it returns to normal factory specifications. It has been determined that the Q11 is going into oscillations. The following page shows steps for modifying the circuitry .

ACTION	SYMBOL	FROM	TO	NEW PART NUMBER
CHANGE	C10	68PF	39PF	BCXG813904Z
MOVE	C18 OR C12	C18 OR C12	C11	BCXG813314Z (IF NEEDED)
CHANGE	L12	0.022 μ H	12K Ω	BRFC011234Z
MOVE	R15	R15	R12	BRFC013904Z (IF NEEDED)
DELETE	C13, R15, R16, C15, L16, R17, R18, R20, R11, C18, C12			NO LONGER USED SEE DRAWING FOR MORE INFORMATION
CHANGE	L11	LE167	0.039 μ H	BLZY0067397
CHANGE	L15	LE455	0.12 μ H	(SUB) BLZY0067107 0.1 μ H
ADD	5pf			BCXG815091Z
ADD	180 Ω			BRPB611814Z
